The Indiana Enhanced I/M Program Evaporative Leak Inspection Study Phase I

Indiana Department of Environmental Management

Envirotest Indiana

November 2007

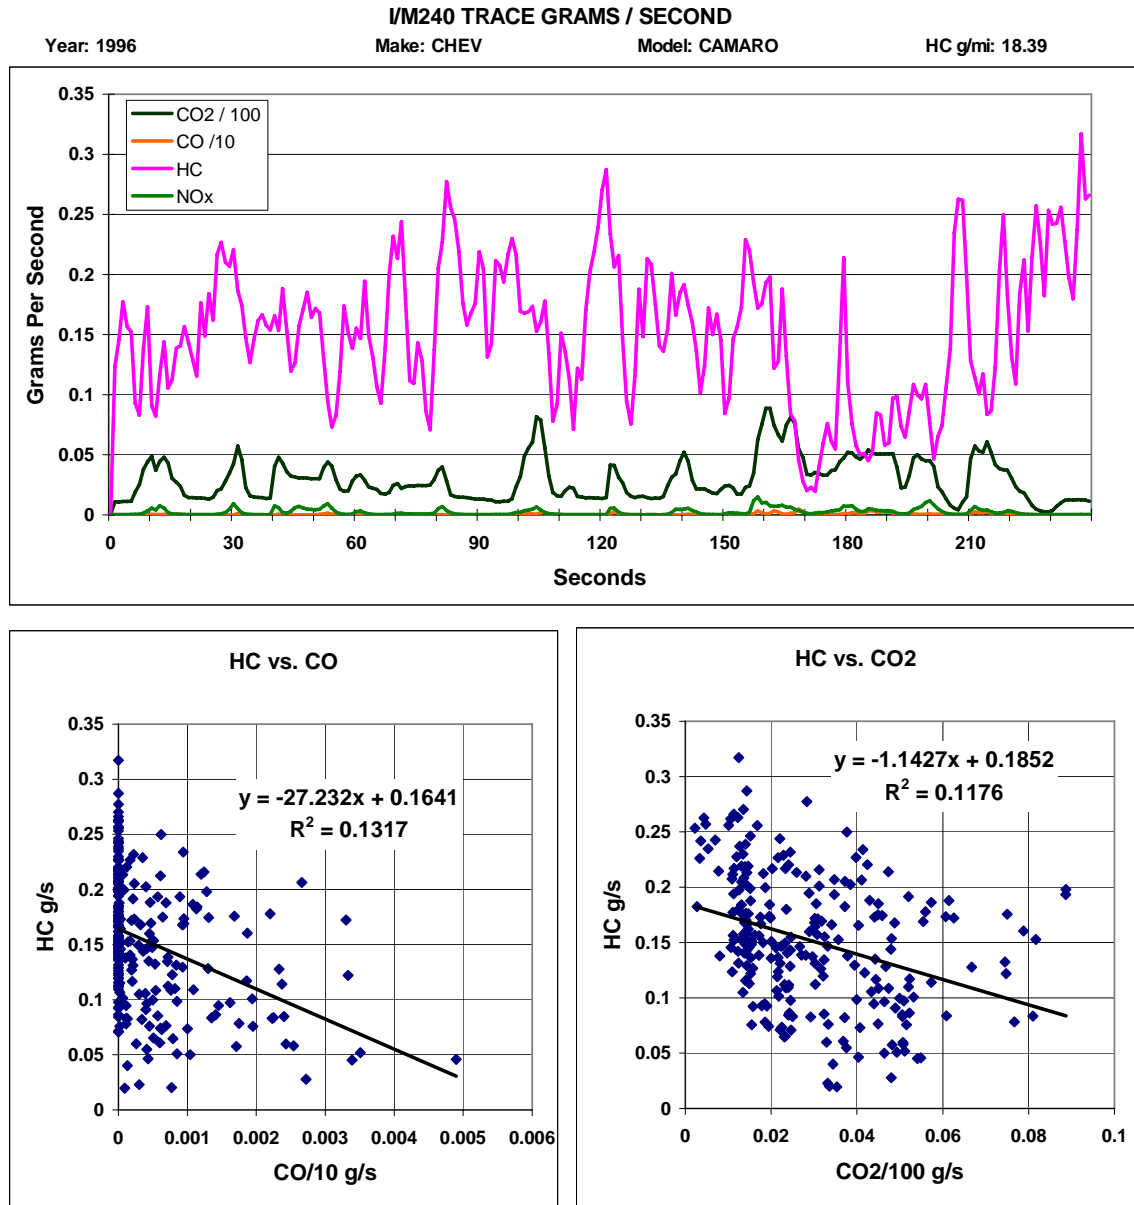
Figure II-2: IM240 Results for Vehicle Failing for High HC due to Leakage (GLL vehicle)

The presence of substantial non-exhaust gasoline vapor coming from vehicles was previously confirmed by IM240 tests. The Colorado Department of Health and Public Environment OBD study, which recruited vehicles from I/M lanes based on high IM240 emissions in test lanes, found five out of 109 vehicles studied had high evaporative rather than high exhaust emissions. The constant volume IM240 emissions collection system drew in not only all the tailpipe exhaust gases but also extra air from around the tailpipe to make up the constant volume. For some vehicles with high evaporative emissions, the air drawn from around the tailpipe contains sufficient evaporative emissions that the vehicles fail the IM240 exhaust emissions test.
